## Vehicle evaluation report

Brand model      Kia Sorento

VIN                KNAPH81ABGA257663

Assessment unit: Carify LLC

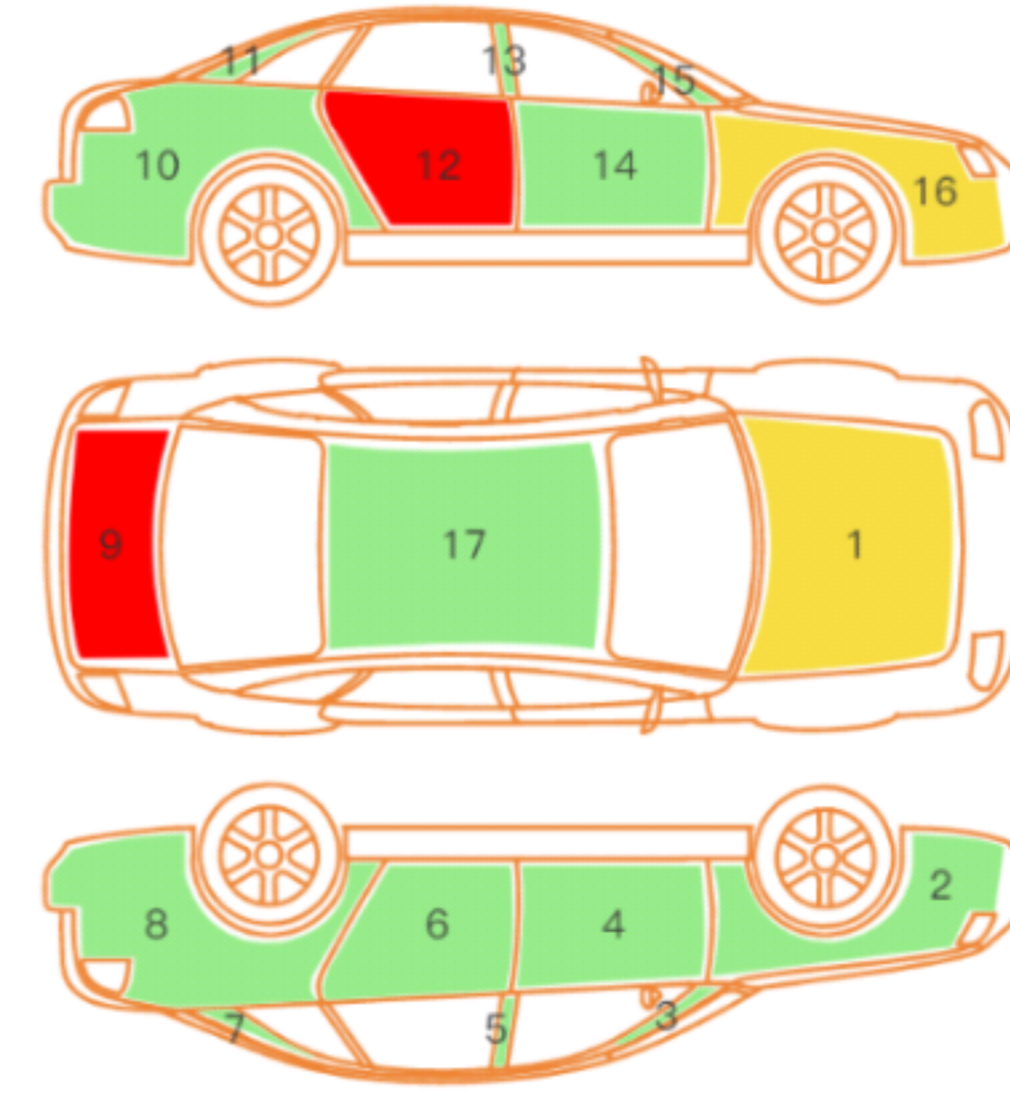
Vehicle parts	Paint thickness						Evaluation results
1.Engine hood	179 FeZn	243 FeZn	243 FeZn	192 FeZn	172 FeZn	-- --	Slightly thick
2.Left Front Fender	136 Fe	123 Fe	83.7 Fe	133 Fe	133 Fe	-- --	Normal

3.Left A Pillar	122 Fe	115 Fe	109 Fe	110 Fe	-- --	-- --	Normal
4.Left front door	131 Fe	122 Fe	110 Fe	117 Fe	-- --	-- --	Normal
5.Left B pillar	90.2 Fe	59.5 Fe	59.4 Fe	-- --	-- --	-- --	Normal

6.Left Rear Door	128 Fe	128 Fe	116 Fe	117 Fe	-- --	-- --	Normal
7.Left C Pillar	104 Fe	107 Fe	104 Fe	121 Fe	-- --	-- --	Normal
8.Left Rear Fender	126 Fe	141 Fe	103 Fe	109 Fe	116 Fe	-- --	Normal

9.Trunk	279 Fe	217 Fe	239 Fe	194 Fe	216 Fe	363 Fe	Ultra thick
10.Right Rear Fender	103 Fe	104 Fe	107 Fe	111 Fe	-- --	-- --	Normal
11.Right C Pillar	115 Fe	106 Fe	87.5 Fe	-- --	-- --	-- --	Normal

12.Right Rear Door	195 Fe	199 Fe	178 Fe	171 Fe	292 Fe	707 Fe	Ultra thick
13.Right B Pillar	80.9 Fe	58.1 Fe	53.5 Fe	-- --	-- --	-- --	Normal
14.Right Front Door	109 Fe	124 Fe	112 Fe	116 Fe	119 Fe	123 Fe	Normal

15.Right A Pillar	116 Fe	131 Fe	90.7 Fe	-- --	-- --	-- --	Normal
16.Right Front Fender	194 Fe	168 Fe	278 Fe	158 Fe	137 Fe	149 Fe	Slightly thick
17.Roof	109 Fe	104 Fe	-- --	-- --	-- --	-- --	Normal
