Vehicle evaluation report

Brand model Kia K5
 Plate No. 04라7252
 Mileage
 Odometer(KM) 123642
 Trip Meter(KM)
 VIN KNAGU411BJA202904
 Color White
 Owner name

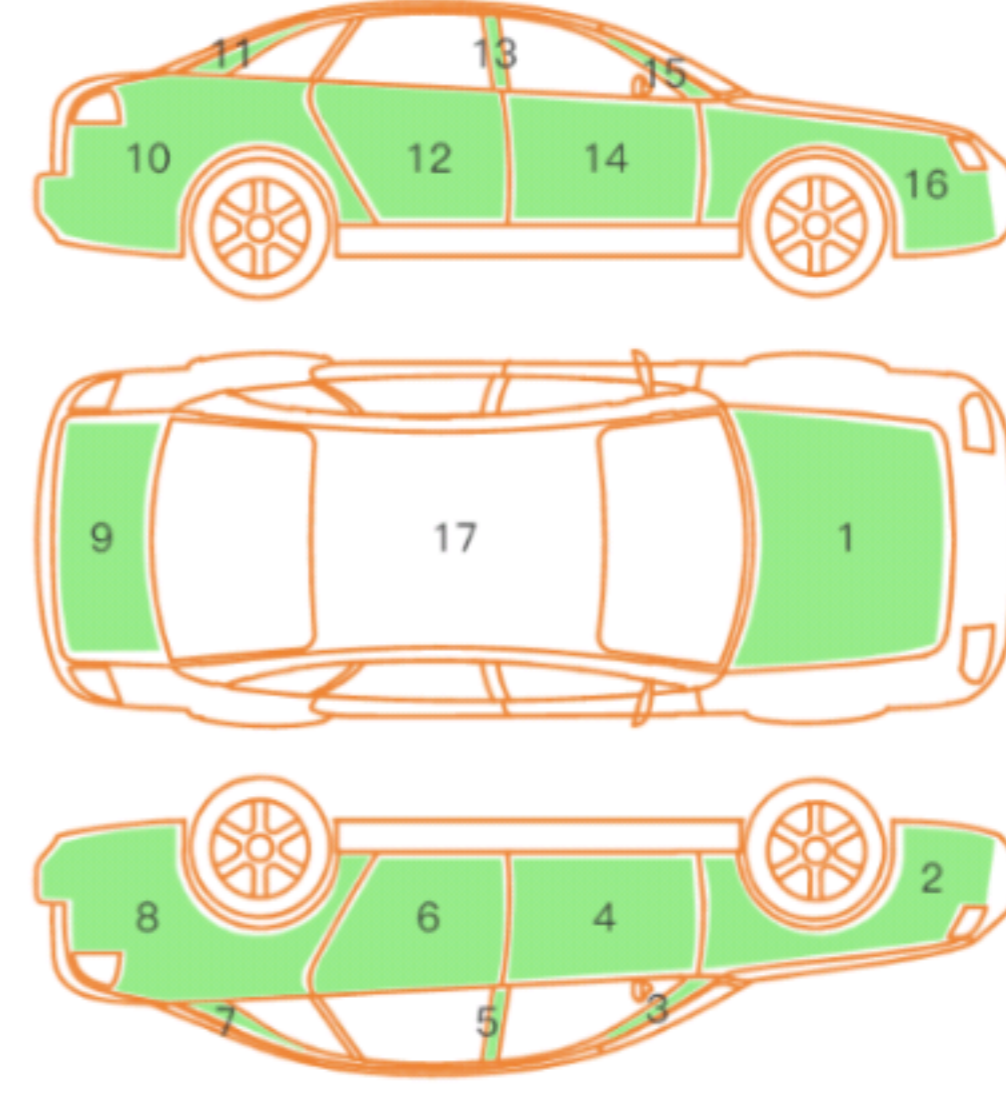
Vehicle parts	Paint thickness						Evaluation results
1.Engine hood	115 FeZn	124 FeZn	114 FeZn	106 FeZn	113 FeZn	115 FeZn	Normal
2.Left Front Fender	90.8 Fe	98.8 Fe	85.0 Fe	93.7 Fe	90.5 Fe	94.0 Fe	Normal

3.Left A Pillar	90.8 Fe	101 Fe	101 Fe	101 Fe	101 Fe	87.9 Fe	Normal
4.Left front door	128 Fe	120 Fe	98.1 Fe	79.3 Fe	112 Fe	108 Fe	Normal
5.Left B pillar	79.0 Fe	79.1 Fe	72.2 Fe	58.8 Fe	75.5 Fe	73.8 Fe	Normal

6.Left Rear Door	122 Fe	113 Fe	103 Fe	89.6 Fe	95.2 Fe	124 Fe	Normal
7.Left C Pillar	91.2 Fe	109 Fe	97.2 Fe	93.9 Fe	-- --	-- --	Normal
8.Left Rear Fender	116 Fe	92.8 Fe	102 Fe	112 Fe	74.2 Fe	81.4 Fe	Normal

9.Trunk	118 Fe	102 Fe	95.5 Fe	73.9 Fe	89.5 Fe	108 Fe	Normal
10.Right Rear Fender	105 Fe	102 Fe	87.2 Fe	79.6 Fe	91.1 Fe	108 Fe	Normal
11.Right C Pillar	97.2 Fe	81.6 Fe	94.1 Fe	89.2 Fe	89.3 Fe	-- --	Normal

12.Right Rear Door	101 Fe	119 Fe	99.8 Fe	92.6 Fe	122 Fe	97.2 Fe	Normal
13.Right B Pillar	91.9 Fe	59.1 Fe	65.0 Fe	58.5 Fe	-- --	-- --	Normal
14.Right Front Door	106 Fe	125 Fe	123 Fe	80.7 Fe	91.9 Fe	115 Fe	Normal

15.Right A Pillar	109 Fe	105 Fe	105 Fe	91.0 Fe	76.4 Fe	-- --	Normal
16.Right Front Fender	98.5 Fe	107 Fe	80.1 Fe	92.3 Fe	82.3 Fe	88.4 Fe	Normal
17.Roof	-- --	-- --	-- --	-- --	-- --	-- --
