Used Car Accident History Report

E200 / 16seo6141

Date of inquiry: 2026-07-28

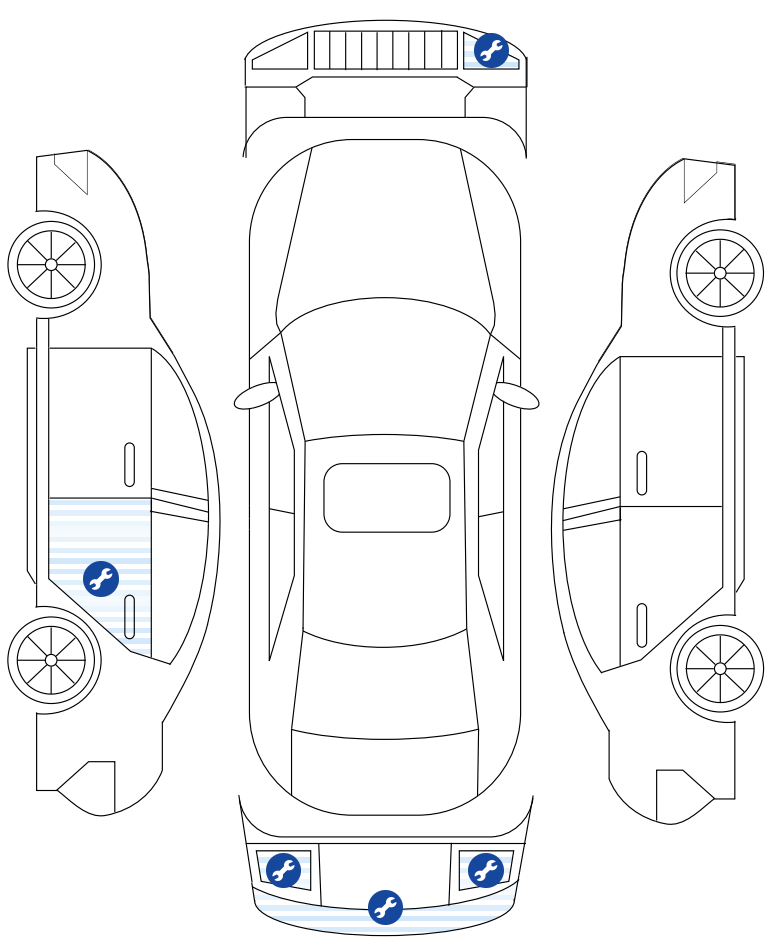
Exterior panel repair unfolded diagram

front bumper		sunroof	
rear bumper	Detachable	loop	
bonnet		Sliding door (left)	
Trunk lid		Sliding door (right)	
backdoor		rear window	
Front door (left)		grille	
Front door (right)		Headlamp (left)	
Rear door (left)	Detachable	Headlamp (right)	Detachable
Rear door (right)		Rear combination lamp (left)	Detachable
Front fender (left)		Rear combination lamp (right)	Detachable
Front fender (right)		Side step (left)	
D-fender (left)		Side step (right)	
Duffender (right)		Center pillar (left)	
windshield		Center pillar (right)

Stamps · · · 0 cases
Detachment · · · 14 cases
Exchanges · · · 7 cases
Sheet metal · · · 6 cases
Repairs · · · 0 cases
Others · · · 4 cases

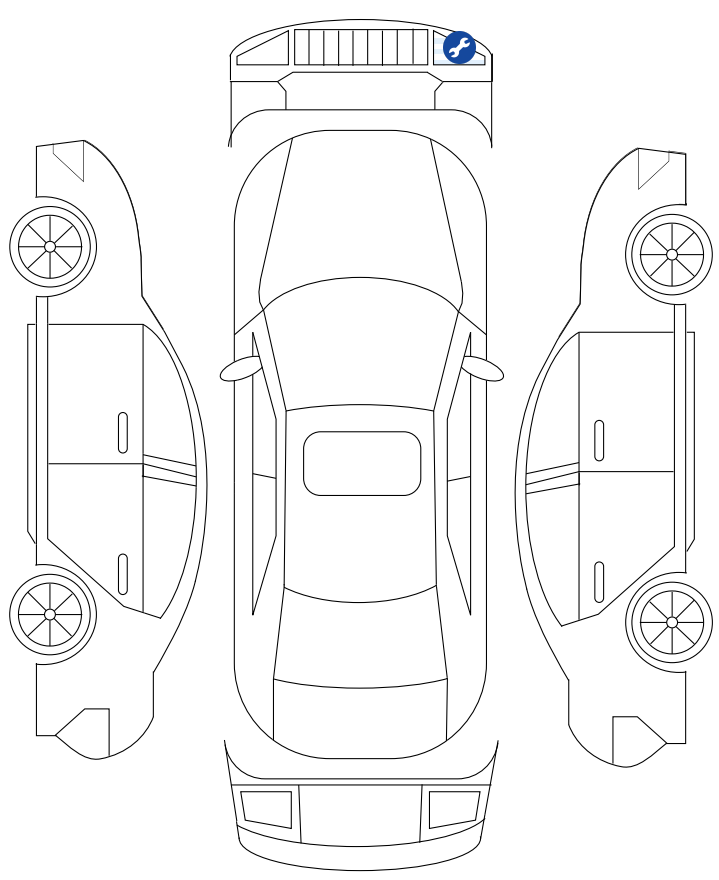
2024-08-31

My car accident occurred (damage)		상대 차 사고 발생 (피해)
My car insurance (processing)	Opponent's insurance (processing)	내 차 보험 (처리)
	Repair (Estimate) Cost 6,385,989 won - 부품 : 4,239,720원 - 공임 : 1,089,300원 - 도장 : 1,056,969원

SCC커버(탈착)
라디에이터그릴(교환)
스티프너(탈착)
전방감지센서(교환)
전방사각지역감지센서(탈착)
전방카메라(라디에이터그릴)(탈착)
전측방경보유닛(BSD센서)(우)(탈착)
전측방경보유닛(BSD센서)(좌)(탈착)
프런트범퍼커버(교환)
프런트어퍼패널(판금)
프런트펜더(우)(판금)
프런트펜더(좌)(판금)
프런트휠가드(로워)(좌)(교환)
헤드램프어셈블리(우)(탈착)
헤드램프어셈블리(좌)(교환)
헤드램프초점조정(에이밍|전체)(조정)
혼(탈착)
혼2번(탈착)
후드(판금)

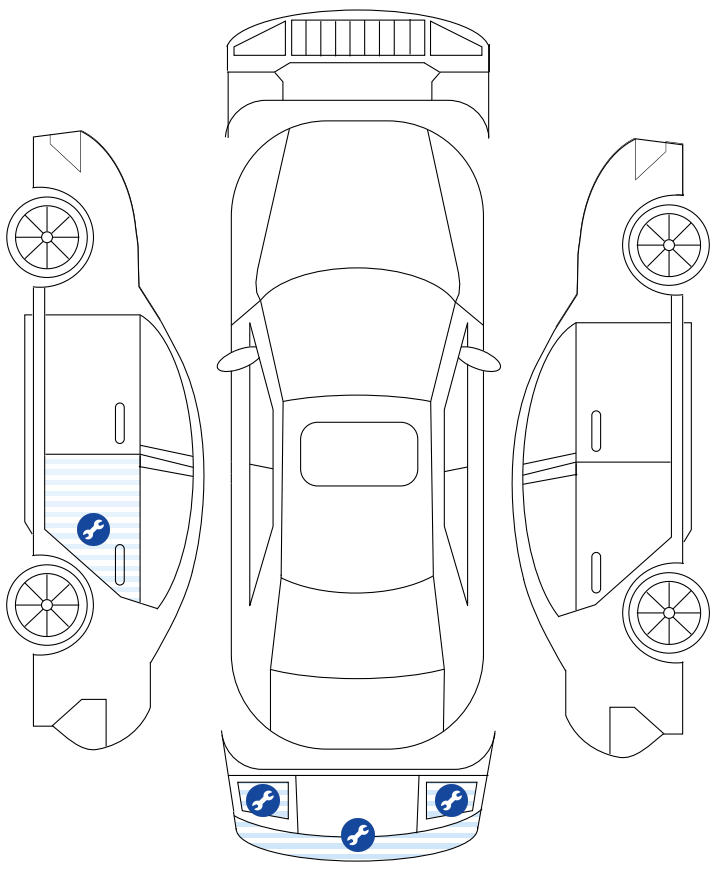
2023-03-15

내 차 사고 발생 (피해)		상대 차 사고 발생 (피해)
내 차 보험 (처리)	상대 보험 (처리)	내 차 보험 (처리)
수리(견적)비용 2,075,000 원 - 공임 : 1,253,000원 - 도장 : 822,000원

MOULDING()
SEALING RAIL()
리어도어(좌)(판금)
리어도어몰딩(좌)(교환)
리어도어벨트몰딩(눈썹몰딩)(좌)(교환)
리어도어아웃사이드핸들(좌)(탈착)
리어범퍼커버(오버홀)
리어범퍼커버(탈착)
리어컴비네이션램프(우)(탈착)
리어컴비네이션램프(좌)(탈착)
리어쿼터패널(리어펜더|아우터)(좌)

(판금)
후방감지센서(탈착)
